## **MORE ROBUST SWITCHES THROUGH IMPROVED CONTROL OF THE SWITCH RAIL**

**BJÖRN PAULSSON & ANDERS EKBERG**

Department of Mechanics and Maritime Sciences  
*CHARMEC / Dynamics*  
CHALMERS UNIVERSITY OF TECHNOLOGY  
Gothenburg, Sweden, 2022  
Report 2022:01

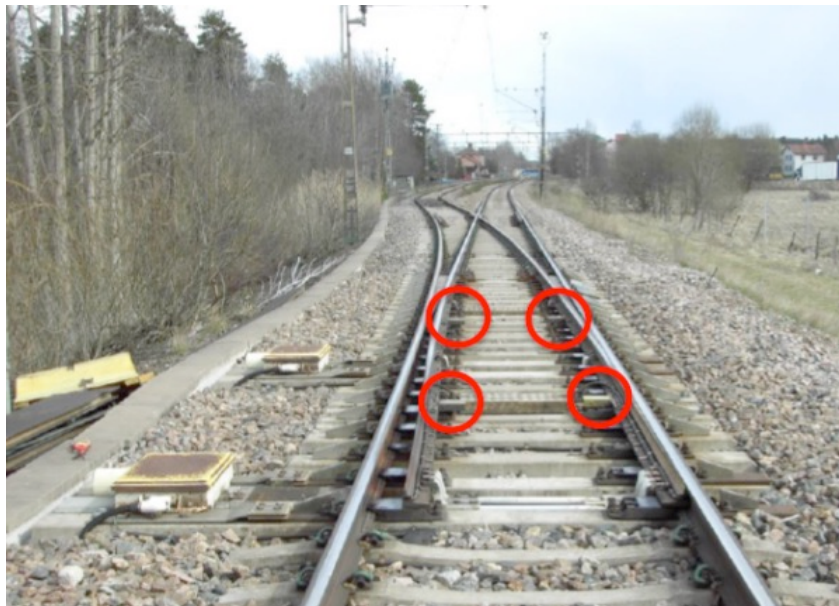
Front:  
Railway switch with four switch rail control sensors indicated. Picture courtesy  
Jan-Erik Meyer, Trafikverket.

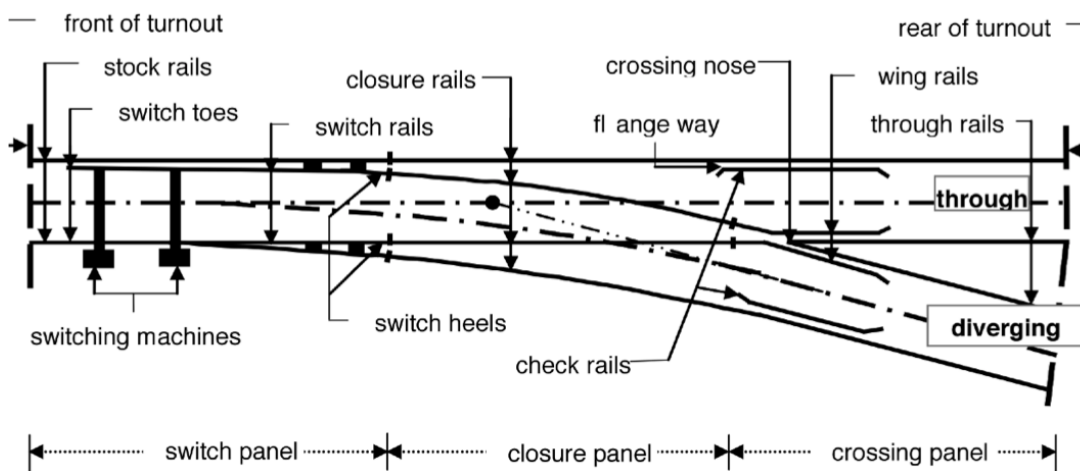
Figure 1 Switch components nomenclature. From [1].

The nomenclature regarding switch components in the report follows Figure 1.

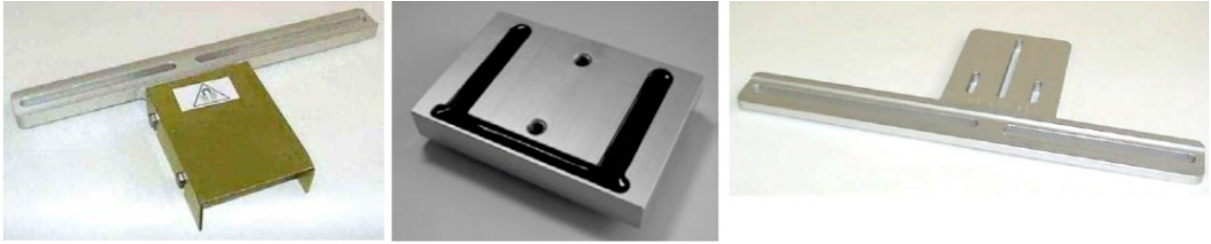
A TKK consists of two parts, a magnetic part which is mounted on the switch rail and a contact which is mounted in the sliding plate at the stock rail [2]. Figure 2 shows the magnetic part.

*Figure 2 Complete magnetic part (left), magnetic system (middle) and mounting plate (right). From [2]*

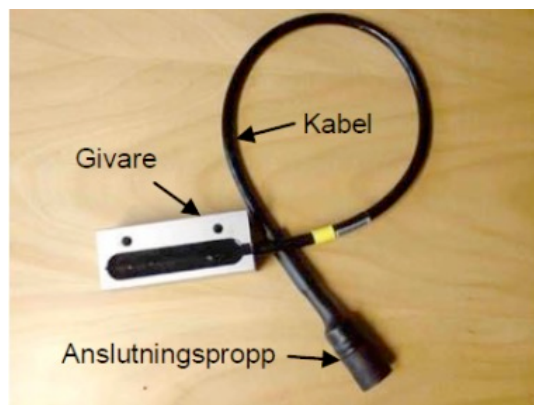
In the eTKK2, the contact is completely electronic and contains of no moving parts. All components are electronic. The contact consists of sensor, cable and connection plug. See Figure 3.

*Figure 3 Contact for eTKK2. (Givare = sensor, Kabel = cable and Anslutningspropp = Connection plug). From [2].*

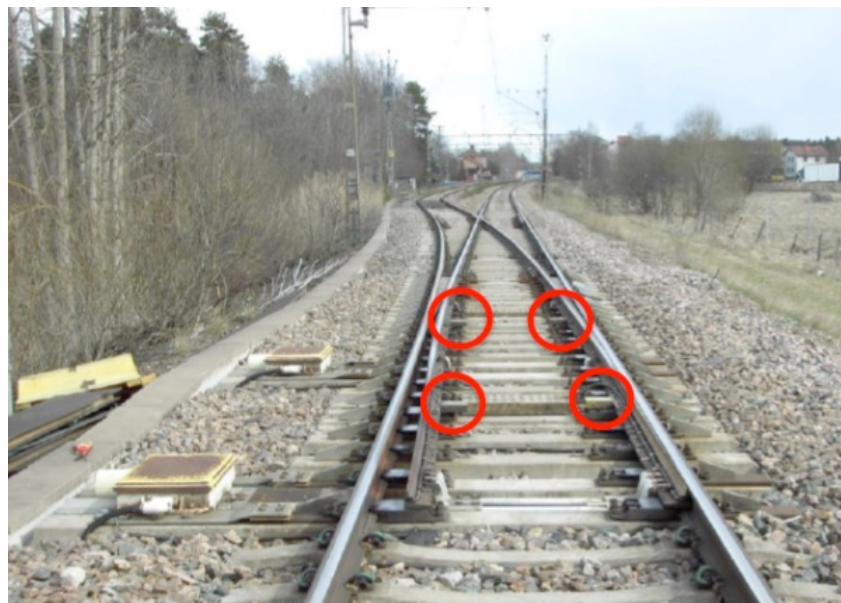
In Figure 4 a 1:15 switch with four mounted eTKK2s (in red circles) is shown.

*Figure 4 Picture of a switch with four TKKs. Picture courtesy Jan-Erik Meyer, Trafikverket.*

In Sweden TTKs are also placed behind the last drive which is the inner drive in figure 4. Despite searching internationally, we have not found any corresponding form of solution with a detector behind the last drive.

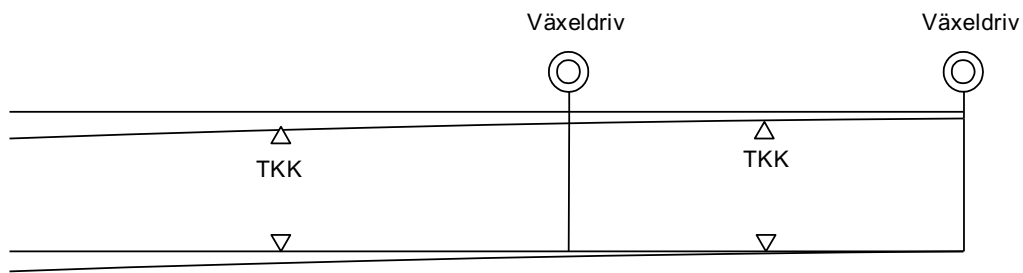
The principle of TKK placement is shown in Figure 5.

*Figure 5 The principle of the placement of four TKKs between and behind the drives ("Växeldriv"). From [2].*

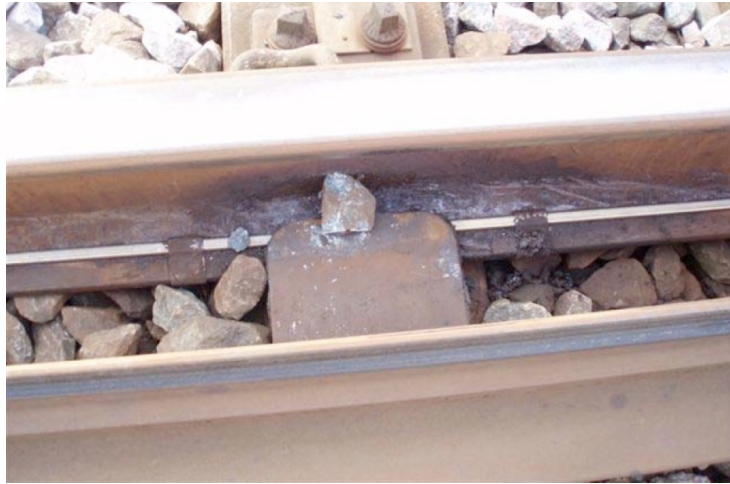
*Figure 6 The ballast stone that caused the derailment in Hamra 2010. From accident report 2010. Picture courtesy Trafikverket.*

A derailment took place in Hamra in 2010 [8] where it was concluded that TKK had indicated an obstacle. A more thorough examination of e-mails, reports, and personal interviews [9] with those involved showed that the first drive had not entered a locked mode. This meant that the wheel flange could penetrate between the switch rail and the stock rail.

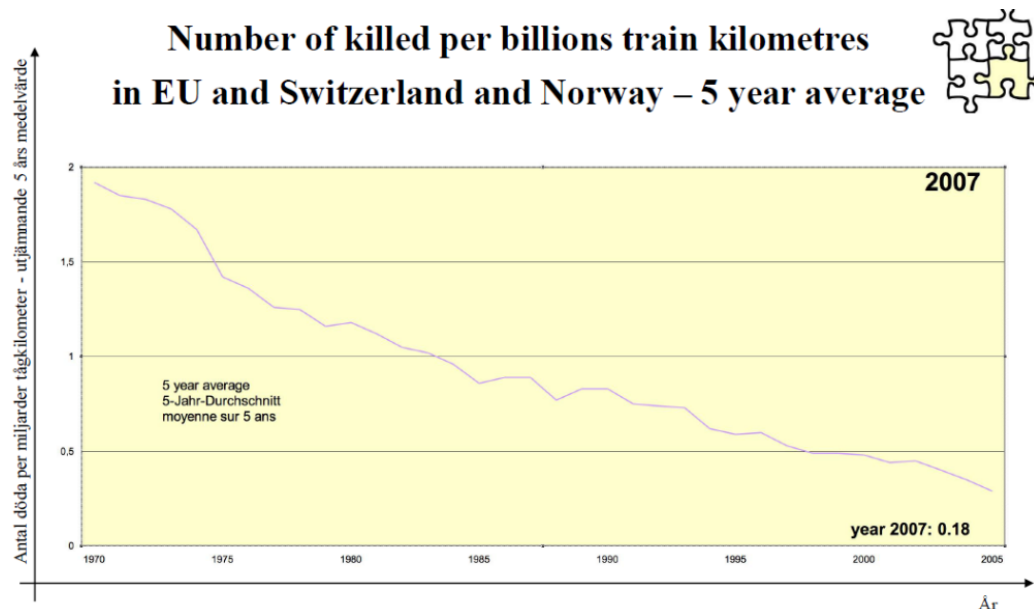
*Figure 8 Number of fatalities per billion train kilometres in EU and Switzerland and Norway – 5-year average during 1970 to 2007 (From the UIC Safety database 2008)*

The safety of train traffic has increased significantly over the past 40 years. The development in Figure 8 shows that there has been approximately a halving of fatalities every 10 years between 1970 and 2007. Regarding derailments, there has been a clear reduction also after 2007 [1].

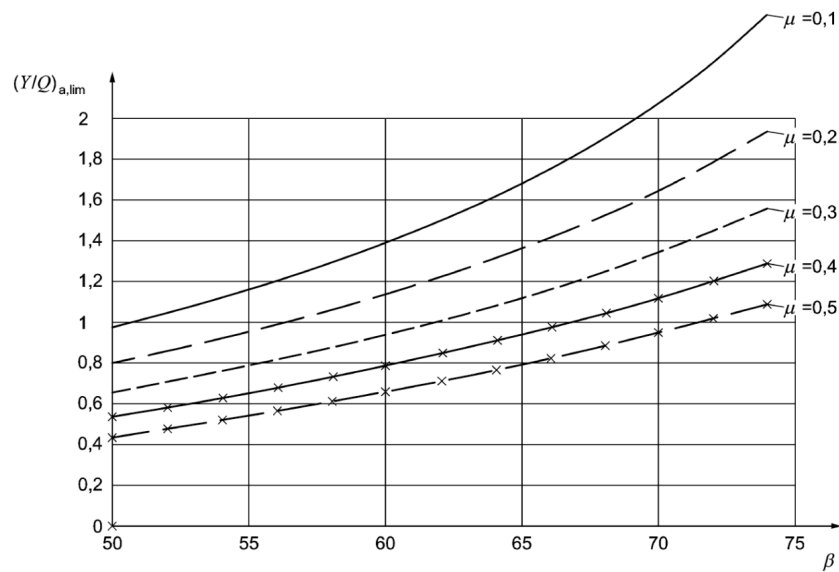
The safety level is not given a specific value in recent Eurocodes. EN 14363-2016 [2] refers to two basic studies, namely the B55 and C138 ORE/ERRI reports that were discussed above. In addition, some limit values are stated. See for example Figure 9 where limit values for  $(Y/Q)$  are provided.

Figure 9 Limit values for  $(Y/Q)$  for variation in the flange angle  $\beta$  and the friction coefficient  $\mu$ . From [2].

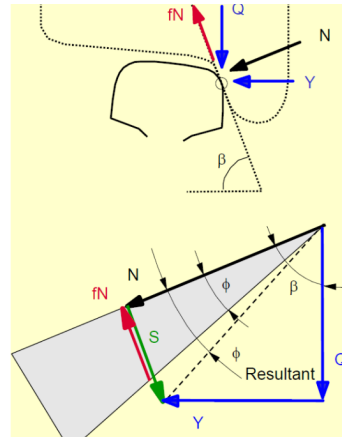
Figure 10 Excerpts from [3]. Reference is made to [205] which is ORE C138 Rp8.

To understand the current relevance of the result from C138, one may consult the handbook Modern Railway Track from 2014 [3]. In that handbook, reference is made to ORE 138 Rp8, see Figure 10 and Figure 11.

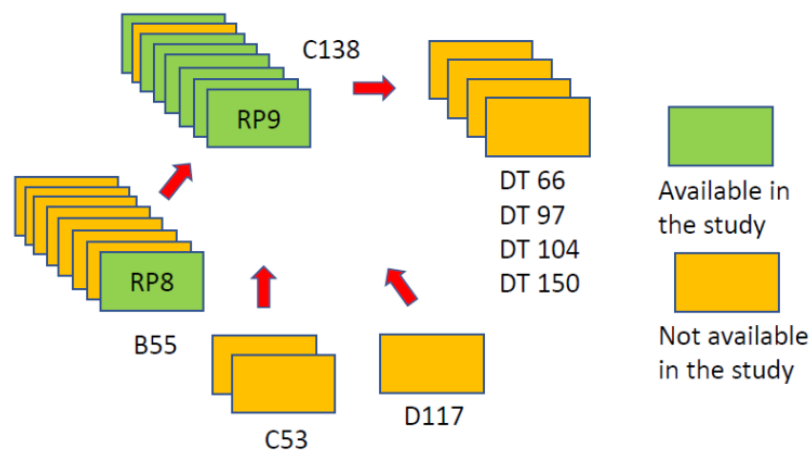
Figure 12 ORE C138 and some other linked documents.

ORE C138 consists of nine reports and four technical documents. It contains some 1500 to 2000 pages. The work with C138 was conducted during 1973–1986. Extensive studies were performed to define permissible maximum values for  $Y$  (lateral) and  $Q$  (vertical) forces and related derailment criteria. ORE C138 refers to ORE B55 [6], ORE C53 [7], and ORE D117 [8]. Figure 12 shows an outline of the relation between the different reports. The reports studied in the current investigation are shown in green.

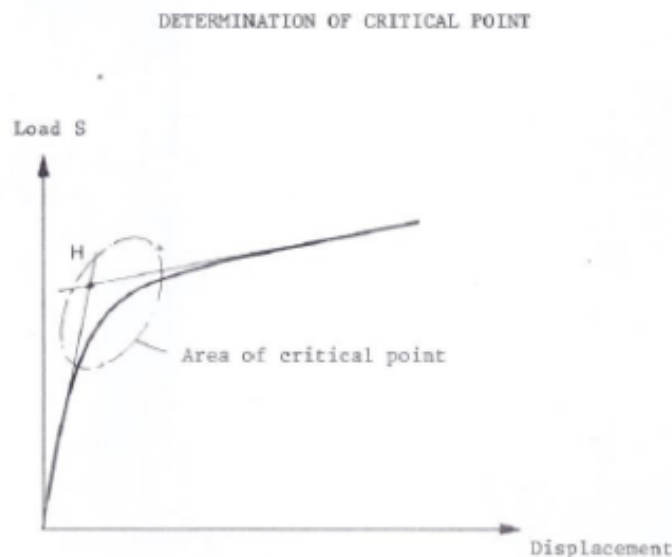
*Figure 14 Load displacement curve to find the area of critical point H regarding track shift. From [5].*

The length of the track section with lateral track displacement is 8 or 9 sleepers, corresponding to some 5 meters. The maximum track displacement tested is 15 mm.

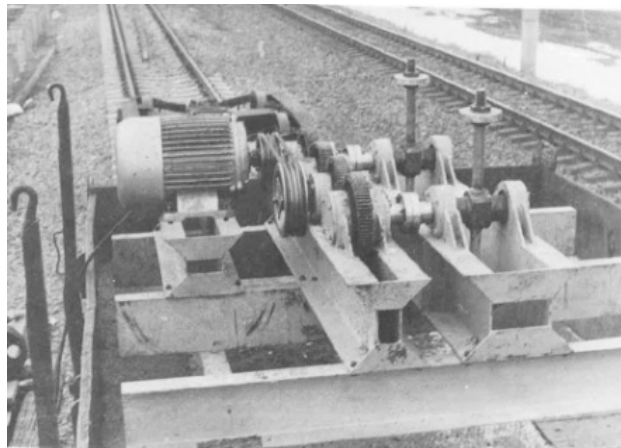
*Figure 15 View of the vibrator used in tests. From [5].*

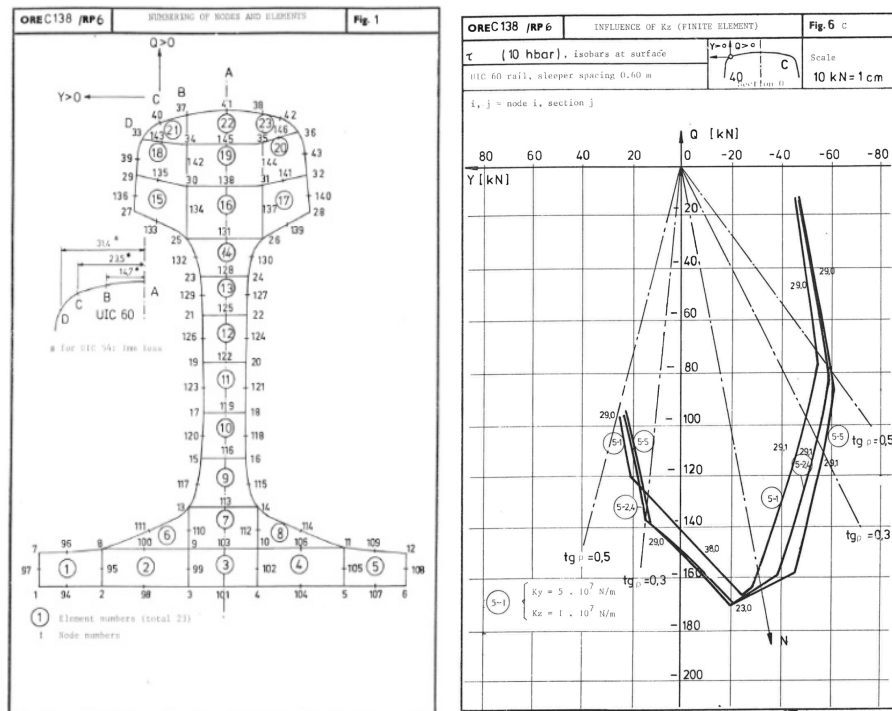
Figure 16 Examples on FE-mesh and isobar for UIC60 and 60 cm sleeper spacing. From [5].

In RP6, calculation methods from RP2 and DT 104 are used. The effects of vertical and horizontal rigidity of the track, sleeper distance, wheelbase and rail profile are presented using isobar plots. Calculation results are compared with measurements.

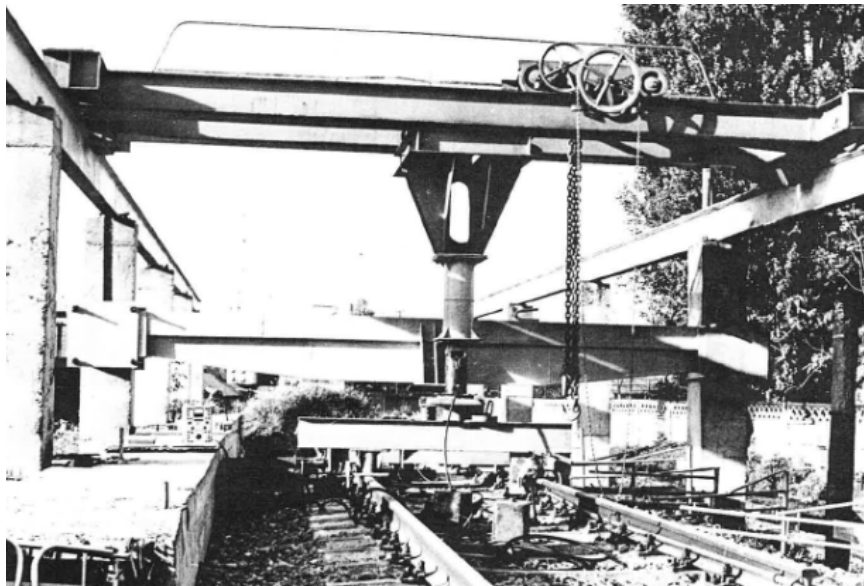
Figure 17 General view of the test rig used. From [5].

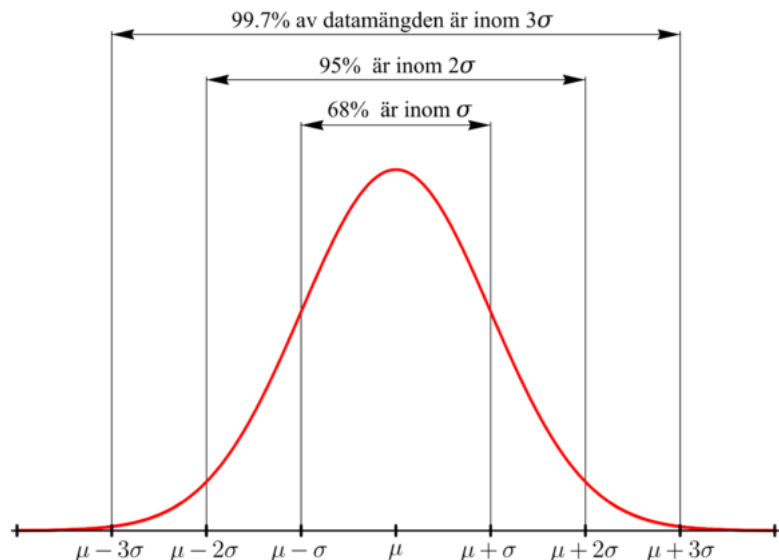
Figure 19 Normal distribution with indications of one, two and three standard deviations ( $\sigma$ ). (By Svjo - CC BY-SA 4.0).

In B55 a normal distribution is used, see Figure 19. Values within one standard deviation ( $\sigma$ ) from the mean ( $\mu$ ) constitute 68.27% of the data set; two standard deviations constitute 95.45% of the data set and values within three standard

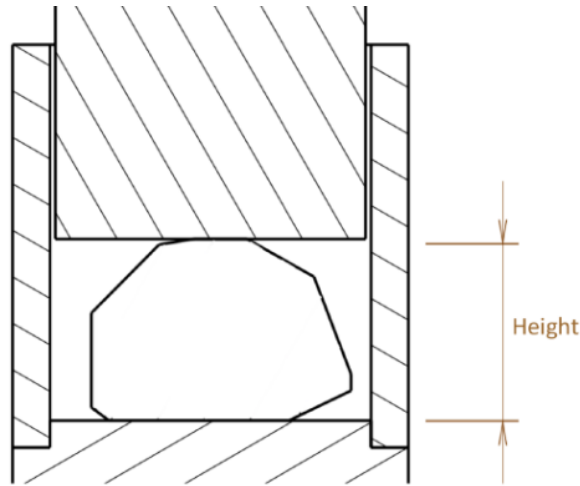
Figure 20 Cross section of the hydraulic press test set up. From [1].

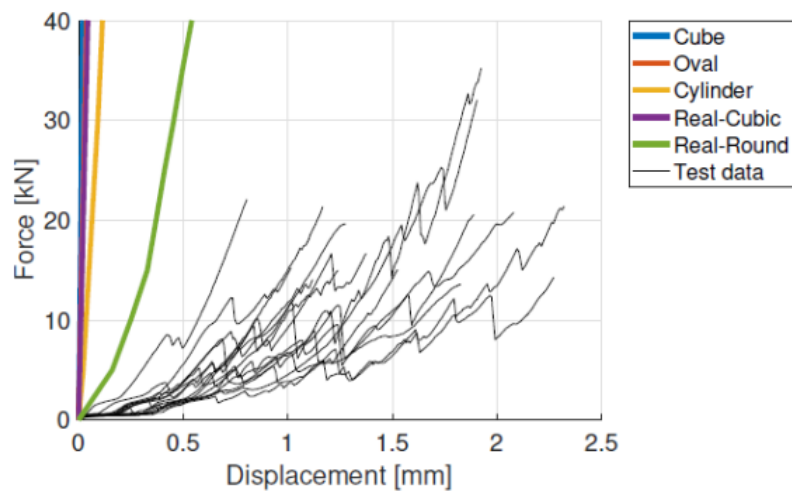
In the ballast crush tests, 15 stones were tested. Figure 21 shows the results of these, and also the predicted deformation behaviour for idealized stone geometries (cube, oval, cylinder, real-cubic and real-round) for reference.

Figure 21 Displacement predicted by FE analyses and evaluated from test data. From [1].

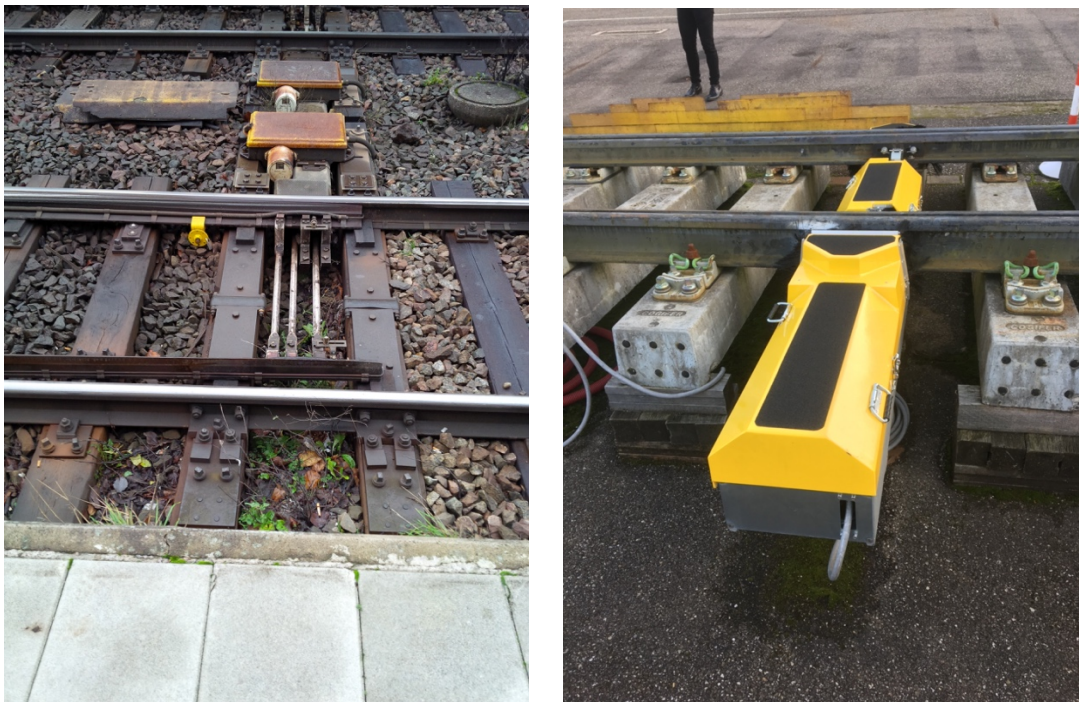
The deflection device that handles the movement of the switch rail is in everyday speech and in the latest Eurocodes referred to as a drive. The drive imposes the (pushing or pulling) force on the switch rail using bars. This induces a movement between the two extreme positions that are secured by a locking device. The force is partially adjustable and can vary between 4.0 and 6.5 kN. In Sweden, 6.5 kN is commonly used.

*Figure 22 Two types of drives: To the left a traditional design with open bar installation, and to the right a modern design with built-in bars of the type Easyswitch. Picture courtesy A Alqvist, Vossloh.*

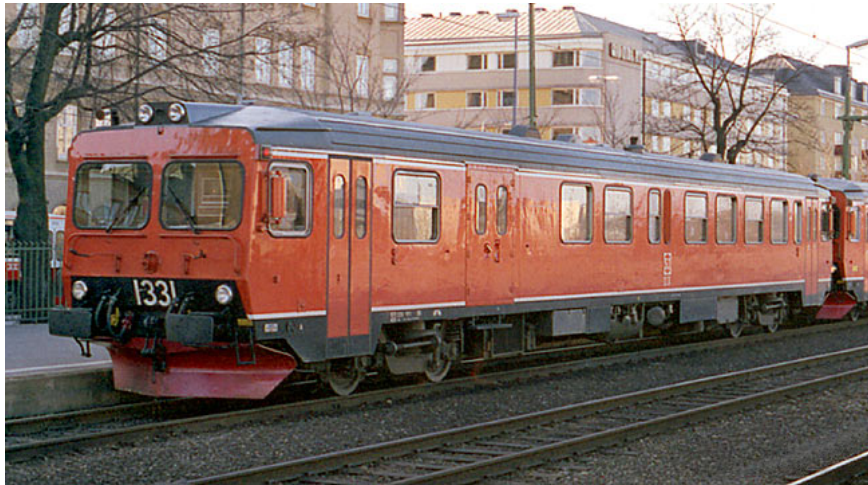
Figure 23 An Y1 passenger train. By Markus Tellerup, CC BY-SA 2.5.

A review of the leading axle of the vehicles in question shows that the axle load is normally 16–21 tonnes. The smallest axle load (11.3 tonnes) was found for an Y1, see Figure 23

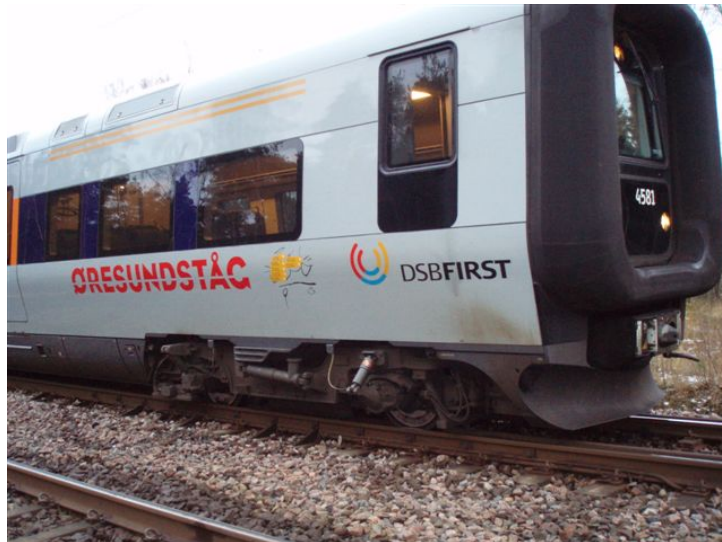
*Figure 24 The derailed X31 at Hamra 2010. From the accident investigation, Picture courtesy Trafikverket.*

The derailment in Hamra in 2010 involved an X31 train (not an SJ train). It had an axle load of 13 tonnes, which is an unusually low axle load.

The most dangerous derailment case has been judged to be when a vehicle with a low axle load enters from the tip of the switch rail and goes into a deviating track. The transition to the deviating track induces a high horizontal force when the vehicle is shifted sideways. This force is aggravated by a narrow rail gauge.

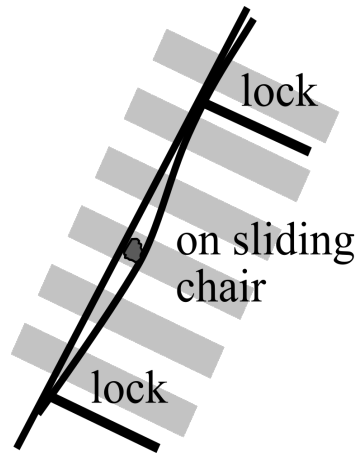
Each drive loads the switch rail with 6 kN. At the same time as there is an obtrusive object that causes a deformation of 30 mm at its location, see Figure 25.

Figure 25 Sketch of the locked drives and the trapped ballast stone.

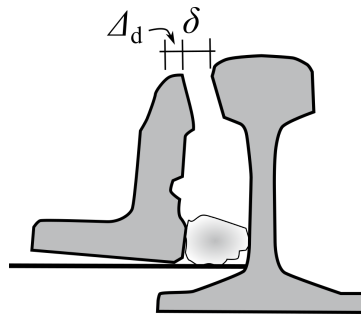
The cross-section deformation where the object is located is indicated in Figure 26. Here  $\delta = 30$  mm is the horizontal deformation that occurs at the moment when the switch rail just reaches the object. When the bottom of the switch rail is obstructed by the stone, a twisting of the switch rail occurs. This causes a reduction  $\Delta_d$  of the gap at the rail head.

Figure 26 Cross-sectional deformation due to loads from the drives.

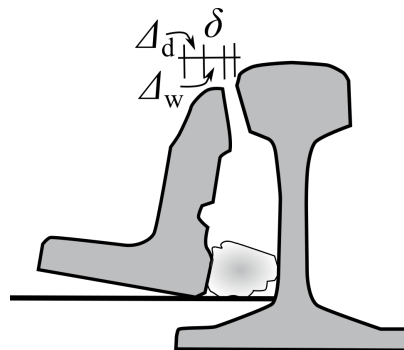
The drives are now locked (the switch rail rests against the stock rail at the drive) with an object that causes a deformation of 30 mm at the switch rail foot. Then we apply another load of 10 kN at a position 15 mm below the tip of the switch rail directed towards the stock rail. This will cause further deformation,  $\Delta_w$ , at the rail head, see Figure 27.

Figure 27 Cross-sectional deformation due to loads from drives and a wheel.

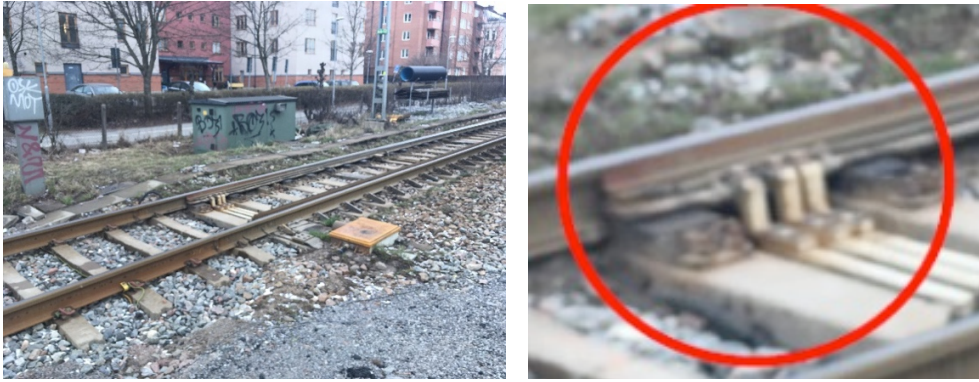
Figure 28 A 1:15 switch with a zoom-in of the connection between the drive and the switch rail. (B Paulsson)

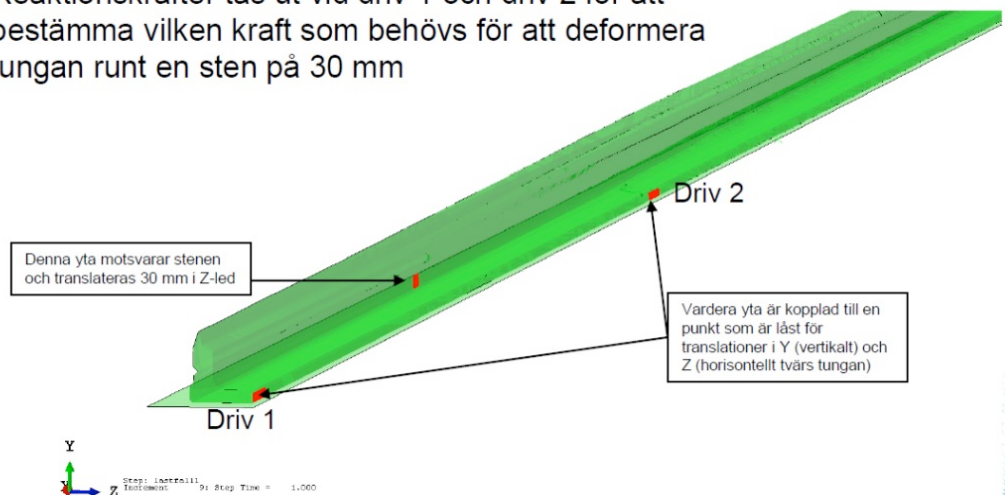
- Reaktionskrafter tas ut vid driv 1 och driv 2 för att bestämma vilken kraft som behövs för att deformera tungan runt en sten på 30 mm

Figure 29 Description of boundary conditions

Figure 29 and Figure 30 describe load cases 1 and 2 (as outlined above) more in detail.

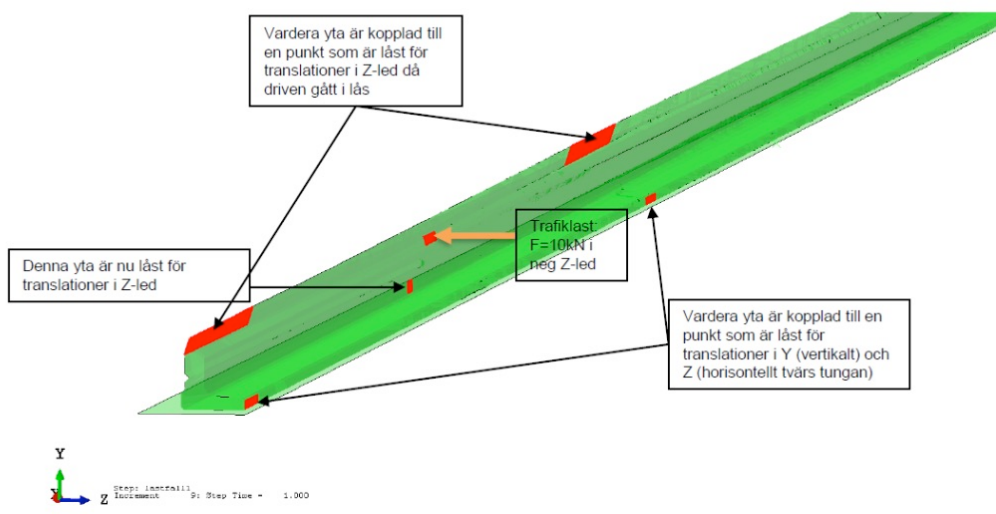
Figure 30 Description of how boundary conditions are modelled.

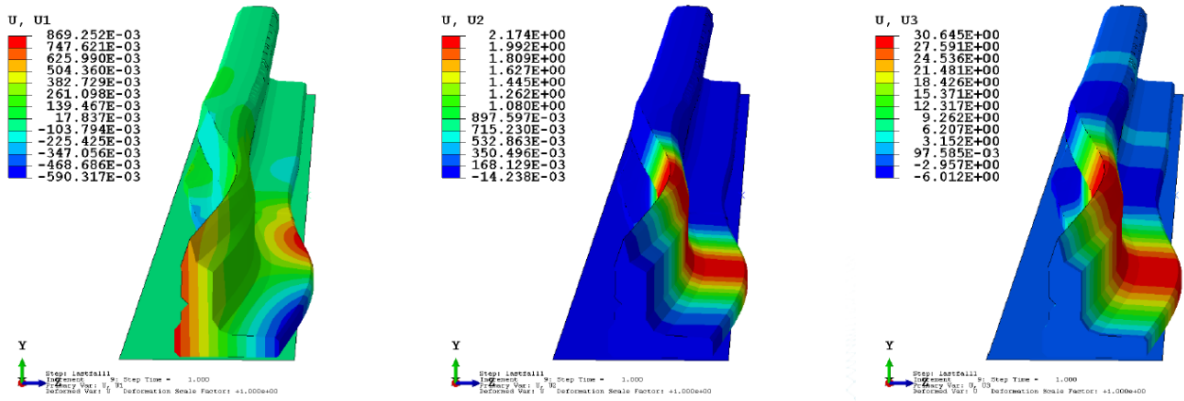
Figure 31 Deformation of a locked switch rail due to a prescribed 30 mm horizontal deformation of the rail foot.

As seen in Figure 31, the simulations capture the horizontal deformation of 30 mm at the foot at the position of the obstacle when a 30 mm stone is trapped between rail foot and support rail. The corresponding vertical lift is 2.17 mm

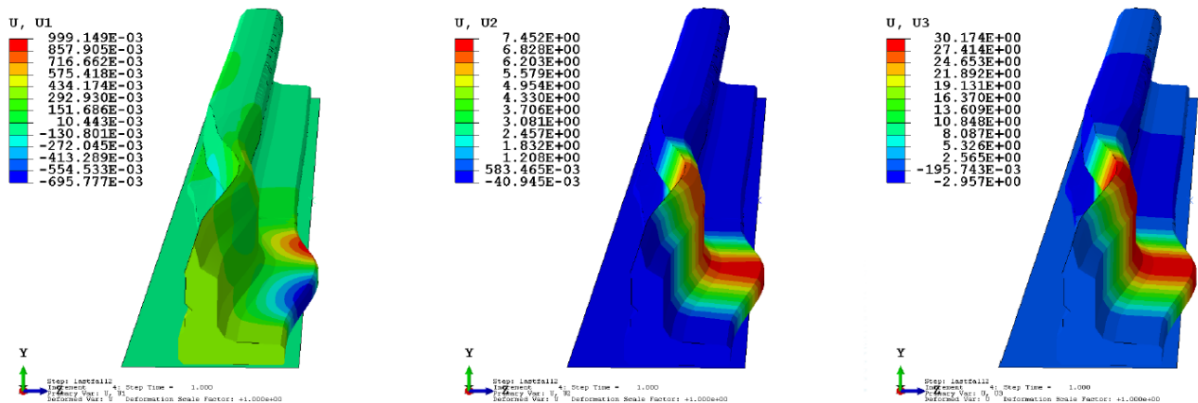
Figure 32 Deformation of a locked switch rail with a 30 mm rail foot deformation due to an applied horizontal wheel load acting on the switch rail head.

The results for load case 2 show a sustained horizontal displacement of 30 mm in the foot (U3 in Figure 32). The vertical lift of the edge of the foot due to the static horizontal load of 10 kN is 7.45 mm (U2 in Figure 32). If the vertical lift of the foot is known, the horizontal movement at the top of the switch rail can be estimated as the ratio of the height of the switch rail (134 mm) divided by its foot length (105 mm) based on the presumption of a rigid cross-section and that the outer corner of the web/foot-connection is fixed during the rotation.
