THESIS FOR THE DEGREE OF DOCTOR OF PHILOSOPHY

# Wetting and drying of aerogel-based coating mortars in Swedish climates

Division of Building Technology

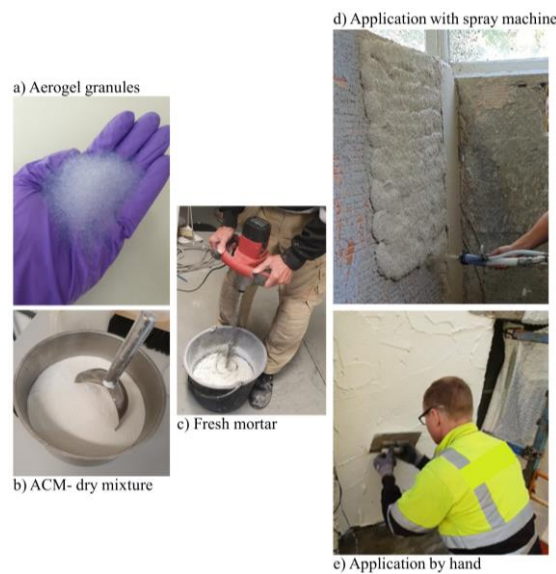
Figure 2. a) Aerogel granules. b) Dry mixture of ACM. c) Preparation of fresh mortar by blending the ACM with water. d) Application with spray machine. e) Application by hand.

Similar to conventional coating mortars, the fresh mortar of ACMs is prepared by blending the dry ACM mixture with water. Subsequently, the prepared fresh mortar is applied manually or with spray machines, as illustrated in Figure 2. As discussed in Chapter 1, ACMs are commonly utilized in an ACM system, which is elaborated upon in Section 2.1.

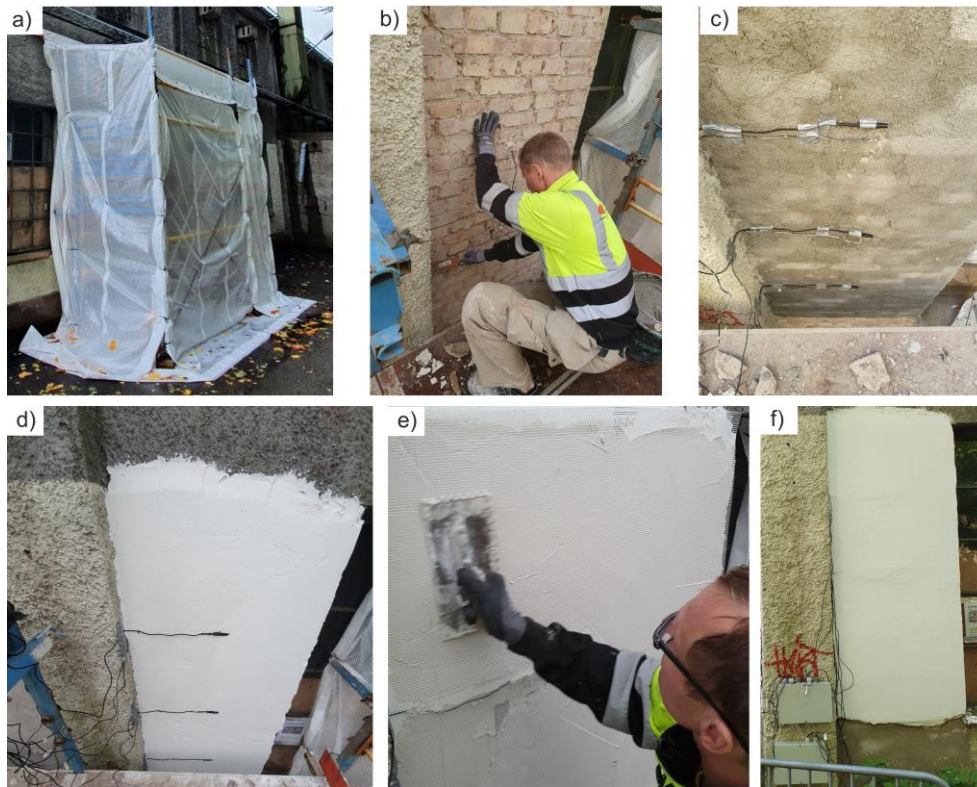
Figure 4. Photographs (**Paper IV**) illustrating the step-by-step application process of the ACM system. The photograph in (a) demonstrates the use of weather protection to mitigate weather-related stresses during the application phase. The process includes preparation (b), removal of the existing coating mortar, and cleaning of the substrate, followed by the successive application of an undercoat (c), ACM (d), the first layer of outer mortar with reinforcement mesh (e), the second layer of outer mortar, and finally, the water-repellent paint. The final appearance of the coating system after the removal of the weather protection is depicted in (f).
