Gren, D., Ahlström, J. (2023). Fatigue Crack Propagation on Uniaxial Loading of Biaxially Predeformed Pearlitic Rail Steel. *Metals*, 13(10). <http://dx.doi.org/10.3390/met13101726>

# Fatigue Crack Propagation on Uniaxial Loading of Biaxially Predeformed Pearlitic Rail Steel

**Abstract:** Rolling contact fatigue loading causes the surface material in the top of the rail to severely deform. The microstructure aligns along the shear direction and the mechanical behavior in terms of plastic flow becomes anisotropic. Cracks are initiated in the severely deformed surface region and propagates along the direction of microstructure flow lines. However, the effect of large shear deformation on fatigue crack growth is not yet well understood. In this study, uniaxial fatigue crack propagation of undeformed and biaxially predeformed pearlitic rail steel R260 has been investigated. The material was predeformed to different deformation states using combined axial compression and shear deformation, corresponding to material found at different depths in the severely deformed surface layer of rails. Fatigue crack propagation rate was dependent on the material state and influenced by both work ha

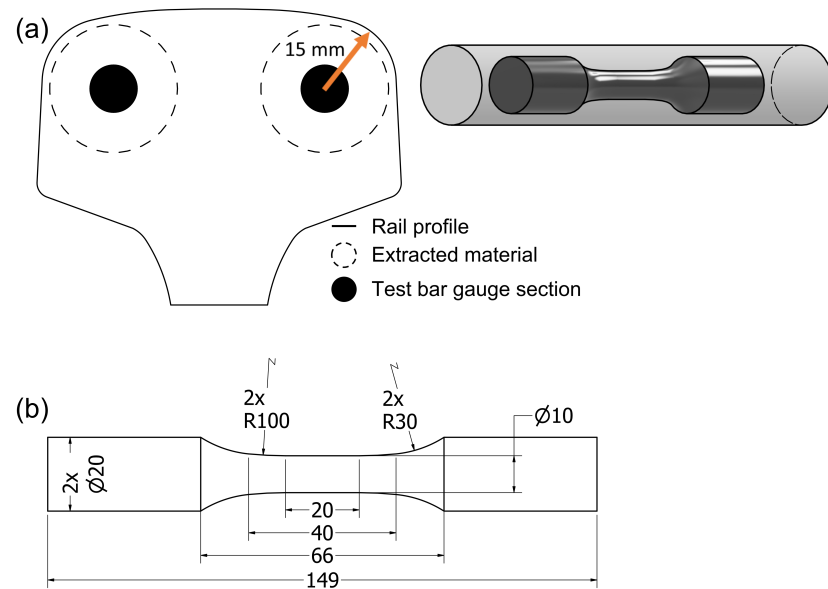
**Figure 1.** (a) Material extraction from virgin rail heads. The figure shows the cross-section of a UIC60 rail head profile. The dashed circle shows where the cylindrical rods were extracted and the black circle shows the material in the gauge section of the test bars. (b) drawing of test bars used for predeformation. Dimensions in [mm].

Uniaxial fatigue crack propagation was studied in predeformed fully pearlitic rail steel R260 (UIC900). The nominal chemical composition of this rail steel is detailed in Table 1. Cylindrical rods with a diameter of 26 mm were extracted from virgin rail heads, as illustrated in Figure 1a. The cylindrical rods were subsequently machined into test bars, following the dimensions provided by the drawing in Figure 1b.

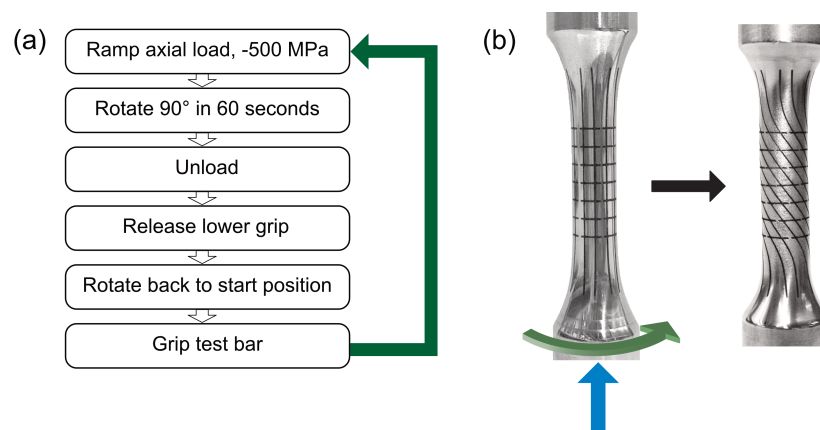
**Figure 2.** The predeformation process is shown in (a) and in (b) the shear deformation resulting after twisting  $3 \times 90$  degrees is visualized by the laser etched grid.

The predeformation method developed by Meyer et al. [23] has been used to replicate the anisotropic surface material found in rails. The predeformation process is a cyclic sequence in which test bars are twisted under simultaneous compression, as illustrated and explained in Figure 2a. In total, two predeformed material states were produced, corresponding to twisting  $3 \times 90$  degrees (PD3) and  $6 \times 90$  degrees (PD6) under a nominal initial compressive stress of  $-500$  MPa. The nominal compressive stress slightly decreases in each cycle as the diameter increases. The test bars used for predeformation were machined according to the drawing in Figure 1b. These test bars were prepared in two steps prior to predeformation. In the first step, they were gradually ground up to P1200 SiC abrasive paper to avoid pre-mature failure during predeformation. Thereafter, in the second step, a grid to measure surface shear strain was applied by laser etching, see Figure 2b. Naturally, undeformed test bars were also included as a reference, and these are called PD0.

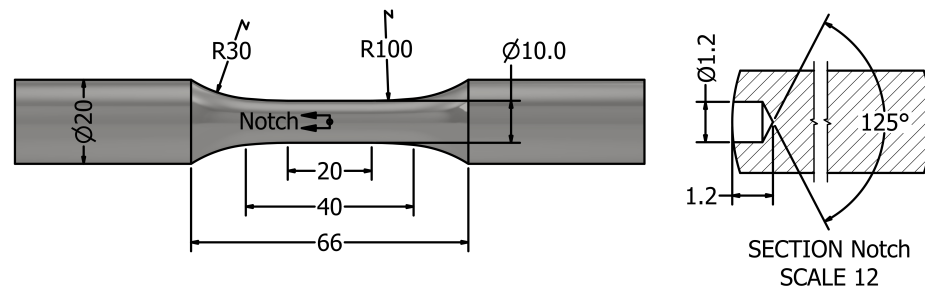
**Figure 3.** Drawing of the notched test bars. Dimensions in [mm].

The compressive load during predeformation causes a slight bending of the test bar gauge section besides decreasing the length/width ratio. Reprofilng was therefore required to make the test bars axi-symmetric and thereby suitable for fatigue testing. Test bars denoted PD6 were reprofiled according to the drawing in Figure 1b. However, it was not possible to reprofile PD3 test bars with this geometry due to the slight bending but limited widening of the profile. Therefore, the dimensions in Figure 1b were adjusted. The gauge section diameter was changed to 9.5 mm instead of 10 mm and the transition radius R30 was changed to R28.

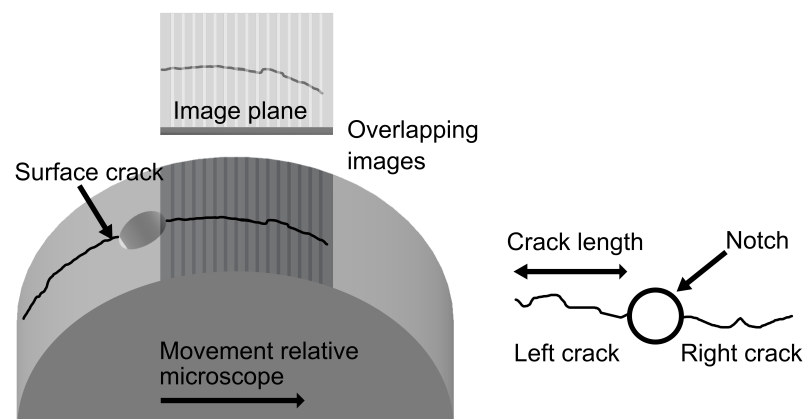
**Figure 4.** Visual representation of image acquisition for crack measurement using stereo and optical microscope, including the definition of crack length reported in Section 3.3.

Crack length has been measured with both stereo- and optical microscope at periodic intervals during the fatigue crack propagation experiments. Multiple micrographs were acquired along the lateral surface of the test bar to cover the whole crack, where each micrograph represents the projection of a small section on the lateral surface, see Figure 4. The acquired micrographs were stitched to form a single micrograph containing the whole crack. This was enabled by letting each section during image acquisition overlap with the adjacent sections. The measurements were conducted every 1000 cycles for the first 10,000 cycles and thereafter every 2000 cycles. Closer periodic measurements were applied towards the end of the fatigue life, when it was anticipated that the test bar would not withstand another full interval. The definition of crack length in the crack propagation measurements reported in Section 3.3 is defined in Figure 4, where the crack length is the horizontal crack extension, measured from the edge of the notch on the image plane. In addition, the crack length was corrected for the curvature of the test bar, i.e., the true length of the crack is longer than the length of the projected crack.

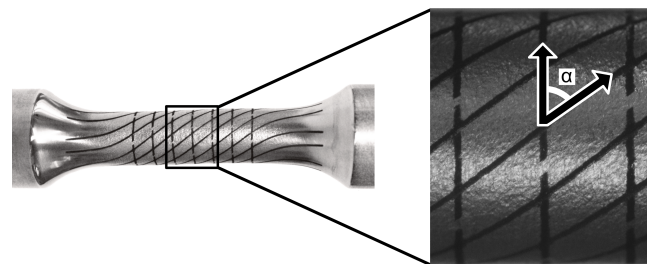
**Figure 5.** Measurement of angle  $\alpha$  (used for calculating surface shear strain in Equation (1)) on predeformed test bars with a laser etched grid.

The laser etched grids on the predeformed test bars were used for surface shear strain measurement. The shear strain was calculated by using Equation (1), where the angle  $\alpha$  was measured between the intersecting lines of the deformed grid (see Figure 5). In total, each test bar was measured at 24 positions evenly distributed around the circumference of the gauge section. The test bar was rotated in steps of 60 degrees and at each rotation, the angle was measured at 4 locations along the focused top surface of the gauge section.

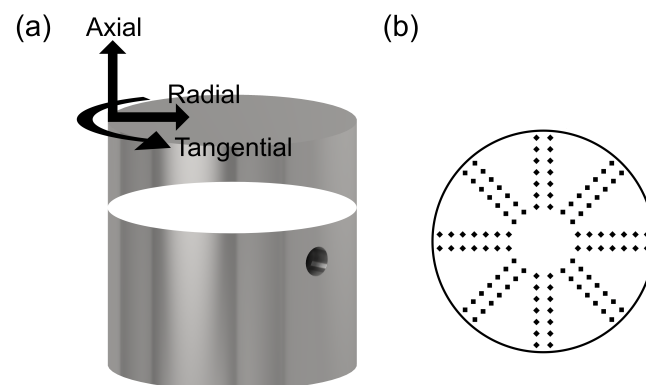
**Figure 6.** Illustration of the location of hardness measurement in (a) and indent pattern used for characterizing the hardness gradient in (b).

The hardness distribution in both undeformed and predeformed samples was determined and evaluated using the Vickers method. The equipment used for conducting the hardness measurements was the hardness tester DuraScan 70 G5 by Struers/Emcotest. In total, hardness was measured on seven samples: two samples for each material state and one reference sample. The reference sample was extracted from a reprofiled PD6 test bar whilst the other samples were extracted after the completed fatigue testing experiment. Figure 6a, shows the location of sample extraction (white cross-section). The cut were made 2 mm from the top of the hole that forms the notch. Hardness was measured along the radial direction on the cross-section on a polished surface according to the indent pattern shown in Figure 6b. In all measurements, the applied load was 5 kgf (HV5), to enable comparison between the samples without risking the possible size effect.

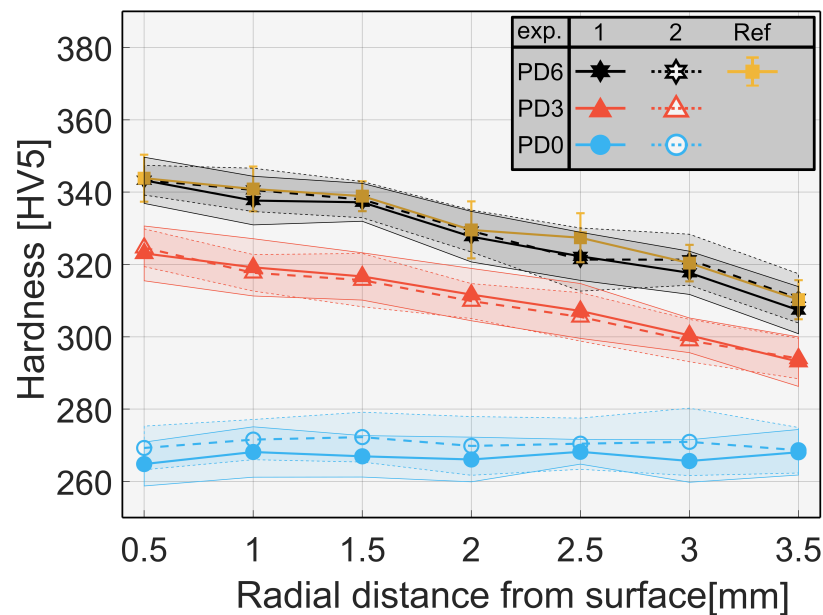
**Figure 7.** Hardness distribution, for both undeformed and predeformed samples, measured along the radial direction from the sample (lateral) surface.

The effect of predeformation on hardness distribution relative the undeformed material state is shown in Figure 7. The presented hardness values were measured along the radial direction, starting close to the sample surface (circumference). From the figure, it can be observed that the undeformed samples have a uniform hardness distribution, averaging 269 HV5 with a corresponding standard deviation of 7 HV5. As expected, these results are in accordance with the hardness requirement outlined in the European rail standard EN 13674-4, for the R260 rail steel. Comparing the hardness distribution of the predeformed samples with the undeformed, a notable difference can be observed. Predeformation introduces significant hardening throughout the cross-section, characterized by a nearly linear decrease in hardness along the radial direction, towards the sample center. This hardness gradient is similar for PD3 and PD6, with PD6 having a hardness level that is approximately 20 HV5 units higher than for PD3. In addition, it can be observed that for the same shear strain level in PD3 and PD6, there is a good agreement between the absolute levels in hardness. For example, the hardness level at 2.5 mm depth in PD6 correspond well to 0.5 mm depth in PD3 (at half the radius, half of the surface shear strain is expected). Lastly, the hardness measurements for the reference sample (PD6) completely overlaps the hardness levels for the PD6 samples, proving that the hardness distribution was unaffected by the fatigue crack propagation experiments.

From the principles of solid mechanics, the hardness gradient can be understood by considering the distribution of stresses and strains in a cylinder subjected to torsion. In this case, the stress and strain increases along the radial direction, away from the center. The shear strain is straightforward to analyze because of the concept that all planes can be assumed to remain planar. Thus, the shear strain varies linearly, from zero at the center, to the measured value at the surface, see Table 3. However, the stress distribution

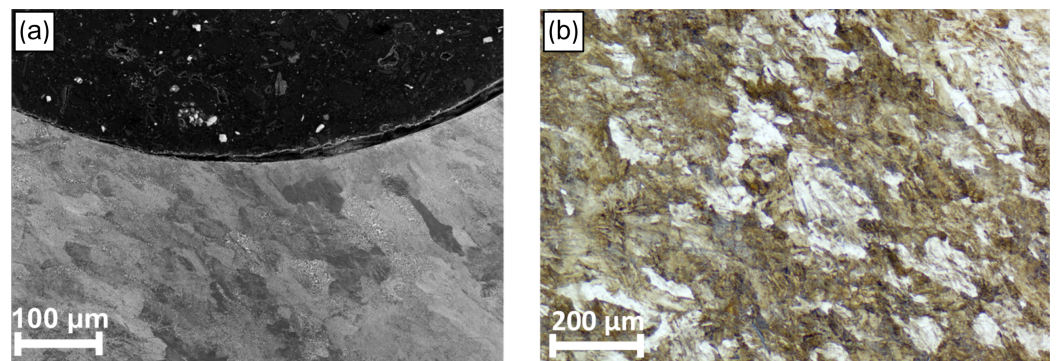
**Figure 8.** Microstructure of a PD3 test bar: (a) SEM micrograph at the notch and (b) optical micrograph, at the cross-section perpendicular to the radial direction, close to the lateral surface.

The micrographs in Figures 8 and 9 shows the microstructure of the deformed material state PD3. These micrographs depicts the cross-section perpendicular to the radial direction, close to the lateral surface, as indicated by the coordinate system in Figure 9. From Figure 8a,b it can be observed that the pearlite colony boundaries are distinguishable and the microstructure shows an overall alignment towards the tangential direction. It must be noted, that the overall microstructure alignment is not equivalent to the individual orientation of the lamellar structure within the pearlite colonies. This is qualitatively exemplified in Figure 9a,b. In Figure 9a, most of the lamellae are aligned along the shearing direction, as opposed to Figure 9b, where the lamellae orientation is observed to vary.

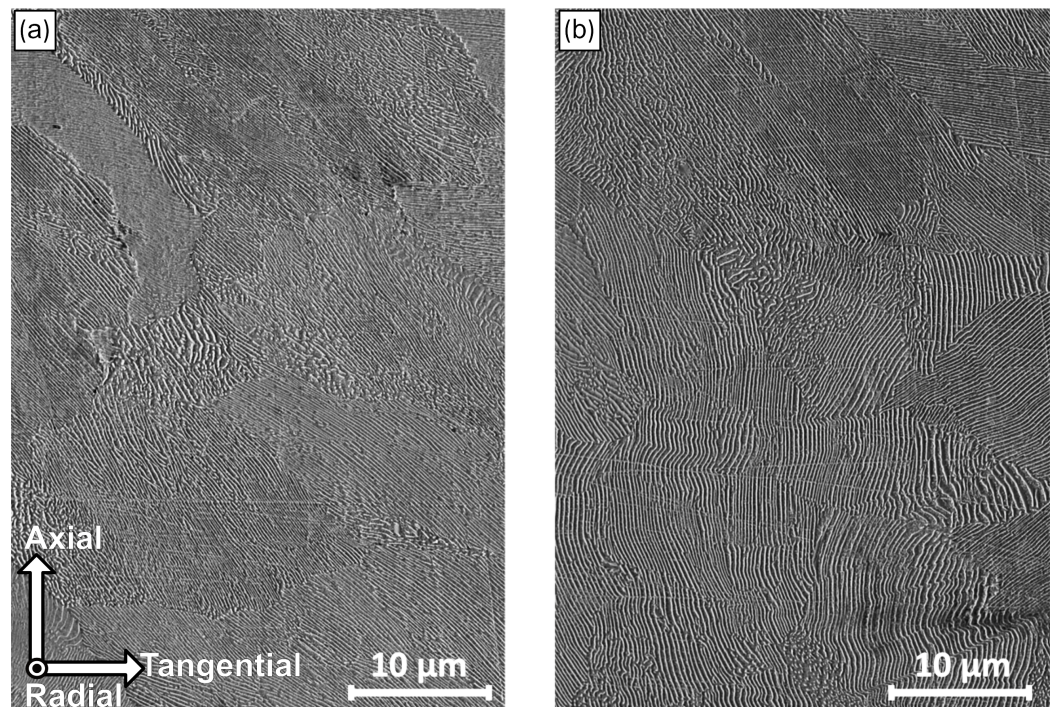
**Figure 9.** Orientation of pearlite lamellae in a PD3 test bar. In (a) most of the cementite lamellae have reoriented along tangential (predeformation) direction whilst no preferred direction is observed in (b).

This variation of lamellae orientation is not unexpected as the reorientation during shear deformation depends on the initial orientation. For example, comparing lamellae oriented perpendicular to the shear direction with lamellae oriented with an angle relative the shear load, the lamellae in the latter case will be more aligned along the shear direction [27,28]. As a consequence of the initial orientation variation, the interlamellar spacing will also vary throughout the structure. In addition, the micrographs of Figure 9a,b also features bent and curved cementite lamellae, which according to Zhang et al. [27] is explained on the basis of large inclination angles relative to the direction of the applied shear load. The reorientation of the cementite lamellae during predeformation was quantitatively measured by Meyer and Nikas [26]. They reported that the orientation of the cementite lamellae is statistically more probable along the tangential direction, at an angle depending on the pre-deformation level.

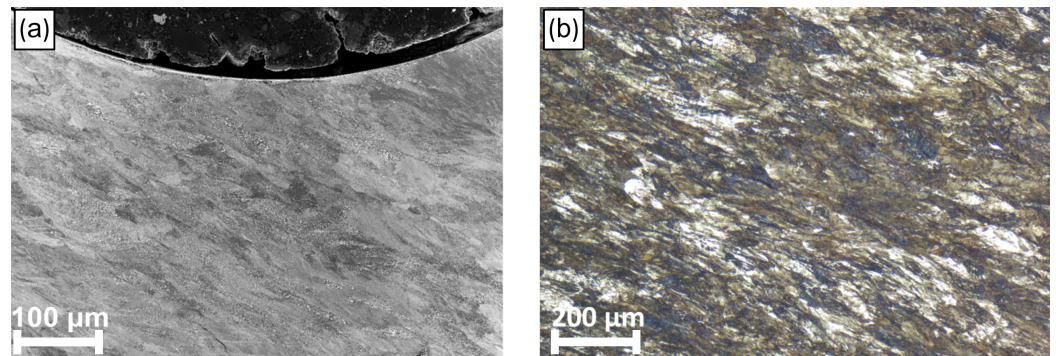
**Figure 10.** Microstructure of a PD6 test bar: (a) SEM micrograph at the notch and (b) optical micrograph at the cross-section perpendicular to the radial direction, close to the lateral surface.

The corresponding microstructure at the cross-section perpendicular to the radial direction, close to the lateral surface, for the predeformed material state PD6, is shown in

Figure 10a,b. Here, the microstructure shows an overall alignment towards the tangential direction. Compared with the material state of PD3, the alignment is more evident and the pearlite colony boundaries cannot easily be distinguished. The variation of the cementite orientation throughout the structure is observed as for the case of the PD3 microstructure. Several areas show curved lamellae, due to shear localization. This is exemplified in Figure 11a,b.

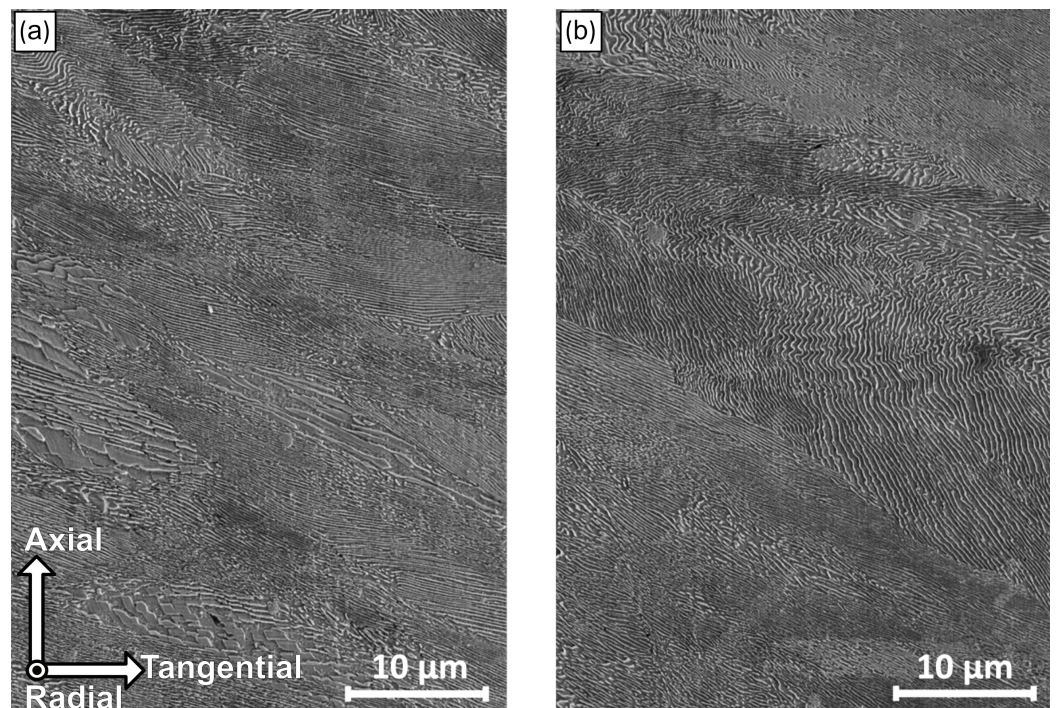
**Figure 11.** Orientation of pearlite lamellae in a PD6 test bar. In (a) most of the cementite lamellae have reoriented along the tangential (predeformation) direction whilst no preferred direction is observed in (b).

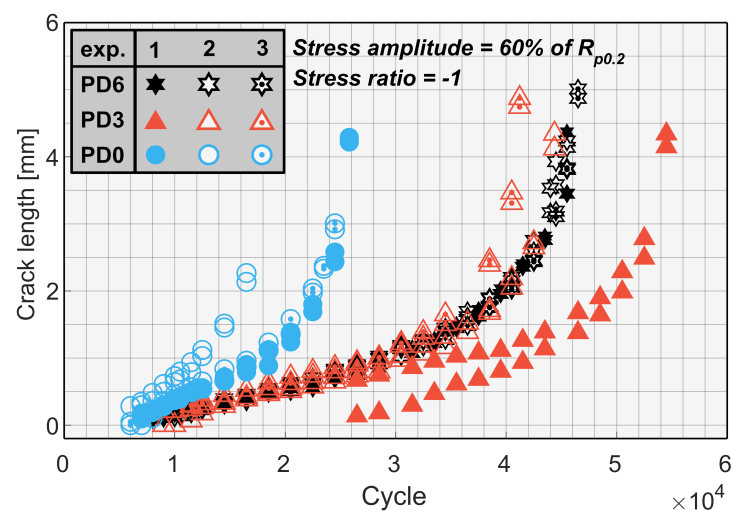
**Figure 12.** The results from the crack length measurements, conducted for the test series loaded with a nominal stress amplitude corresponding to 60% of  $R_{p0.2}$ .

The crack length measurements, resulting from the crack propagation experiments conducted with a nominal stress amplitude corresponding to 60% of  $R_{p0.2,vg}$ , are shown in Figure 12. In the graph, it can be seen how the surface crack length changes with the number of load cycles until failure. Note that in all measurements for each test bars, there are two measured cracks, one crack on each side of the notch. From the crack propagation measurements, it can be observed that the initial crack growth rate is constant, followed by a transition to an exponential increase in crack growth rate. This crack propagation

behavior is expected because the stress intensity at the crack front is dependent on the load bearing area, which reduces exponentially as the crack propagates. The area reduction can initially be considered as negligible, and the stress concentration induced by the notch dominates the local stress condition. Interestingly, the two cracks for each experiment almost extended at the same rate, indicating that the crack front becomes symmetric around the notch; cracks are initiating at each side of the notch, then joining to form a semi-elliptic crack front after some crack growth. This is further supported by the semi-elliptic fatigue fracture surface, see Figure A1.

When comparing the crack propagation resistance, a notable difference between undeformed and predeformed samples is observed. This difference is highlighted by the number of cycles to reach the same surface crack length, which was almost twice as many for predeformed test bars than for the undeformed. However, the predeformed material states PD3 and PD6 exhibit similar crack propagation resistance, except for one notable discrepancy; experiment 1 of PD3, which had approximately 25% longer fatigue life. In this case, crack initiation was delayed on one of the sides, with a subsequent lag in merging and progression into semi-elliptic crack growth, characterized by exponential crack growth rate.

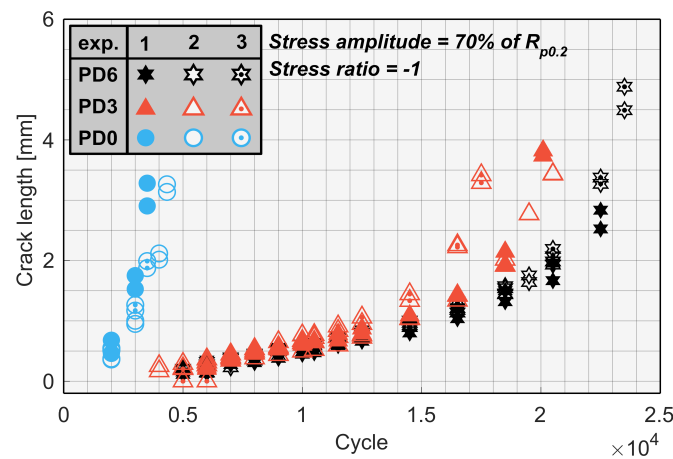
**Figure 13.** The results from the crack length measurements, conducted for the test series loaded with a nominal stress amplitude corresponding to 70% of  $R_{p0.2}$ .

The crack length measurements, for the nominal stress amplitude corresponding to 70% of  $R_{p0.2,vg}$  is shown in Figure 13. Additionally, in this case, the two measured cracks follow each other well and the corresponding fracture surfaces are semi-elliptic, as shown in Figure A2. When compared to the lower nominal stress amplitude, it is observed that the initial constant crack propagation rate is higher, and the transition to exponential crack growth occurs earlier, for all tests. The difference in crack propagation resistance between undeformed and predeformed samples is large, larger than the corresponding difference observed for the lower nominal stress amplitude. In fact, the crack propagation rate in the undeformed test bars is so high that the crack measurement interval was too long to resolve the progression of the crack length. The comparison of the crack growth rates between the predeformed test bars PD3 and PD6 shows that there is a slight difference between them, with PD6 having higher crack propagation resistance. At this stress amplitude, the difference is clearer than what was observed at the lower stress amplitude, but still not drastic.

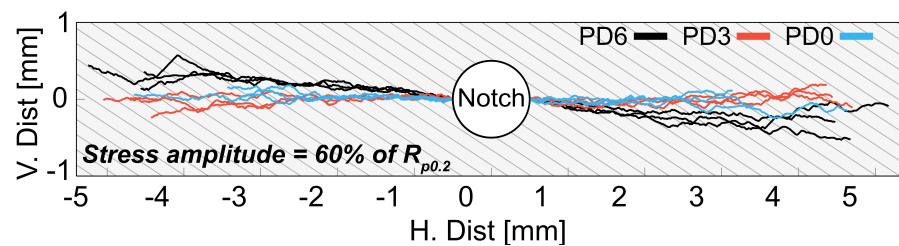
**Figure 14.** The final crack contour on the image plane (see Figure 4) for all test bars, loaded with a nominal stress amplitude corresponding to 60% of  $R_{p0.2}$ .

For the length of the crack contours of the final crack before the fracture was measured on stitched micrographs from optical microscopy, see Section 2.3.2. In this case, the crack length was not corrected for the curvature of the test bar. To examine and visualize the correlation between crack path and material state, the crack surface contours were digitized. Digitization was done by extracting the crack contour in a commercial photo editing software. The pixel data of the crack contour was converted to spatial data by using a Matlab script. The processed crack contours are visualized in Figures 14 and 15 for respective nominal stress amplitudes. The background grid represents the magnitude of surface shear deformation in PD6 test bars along the direction of microstructure alignment. It can be observed that for both nominal stress amplitudes, the surface crack in the undeformed material is on average straight with local crack kinking, as is the crack path for PD3. Comparing these crack paths with the crack paths of PD6 in the lower stress amplitude experiments, it can be seen that there is a slight difference in the average inclination angle. However, at the higher stress amplitude there is no distinct difference between the different material states. The crack paths are further discussed in Section 4.2. Validation data for the crack contours is available as Supplementary Material.

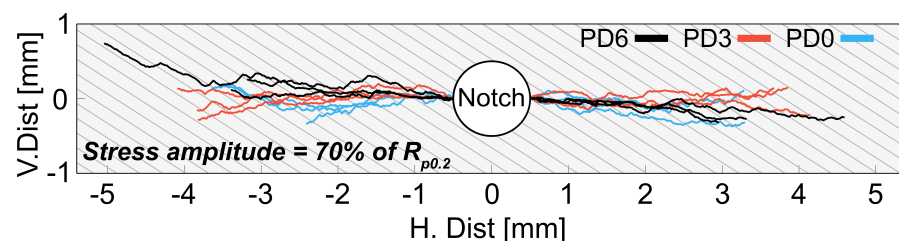
**Figure 15.** The final crack contour on the image plane (see Figure 4) for all test bars, loaded with a nominal stress amplitude corresponding to 70% of  $R_{p0.2}$ .

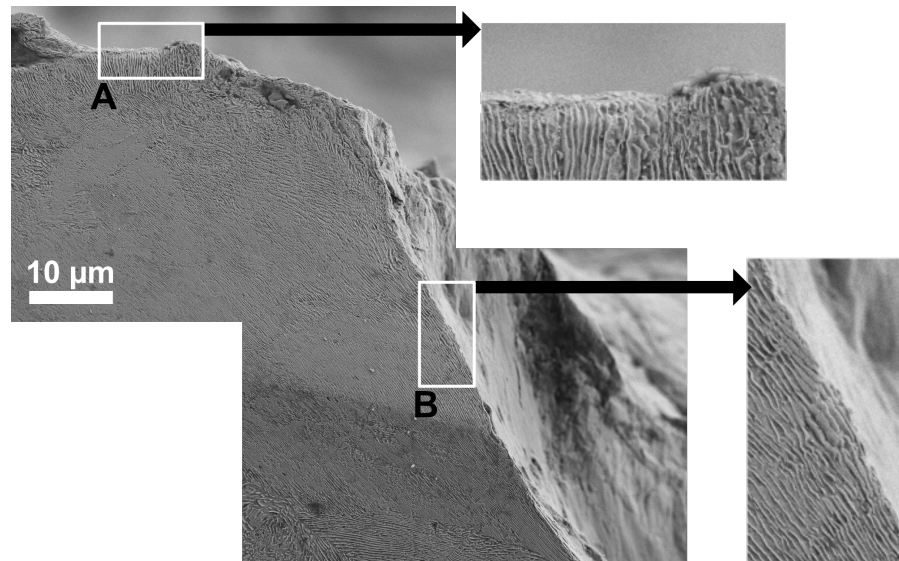
**Figure 16.** Surface crack path (on the lateral surface) for a PD3 test bar. The figure exemplifies the observed variation in crack growth direction on the surface. The detailed views A and B show the surface crack growth across and along the cementite lamellae, respectively.

The surface crack path relative the orientation of the cementite lamellae was closely examined in a scanning electron microscope (FEGSEM). The correlation between crack growth direction and orientation of the cementite lamellae was found to be limited. The variation of crack growth direction with respect to orientation of the cementite lamellae is exemplified in Figures 16 and 17, for PD3 and PD6 samples. These figures qualitatively demonstrate the variation in crack growth direction; only along small sections is the crack observed to propagate along the cementite lamellae, see detailed view B and A in Figures 16 and 17. In other sections the crack propagates across the cementite lamellae, as exemplified in the detailed views A and B of Figures 16 and 17.

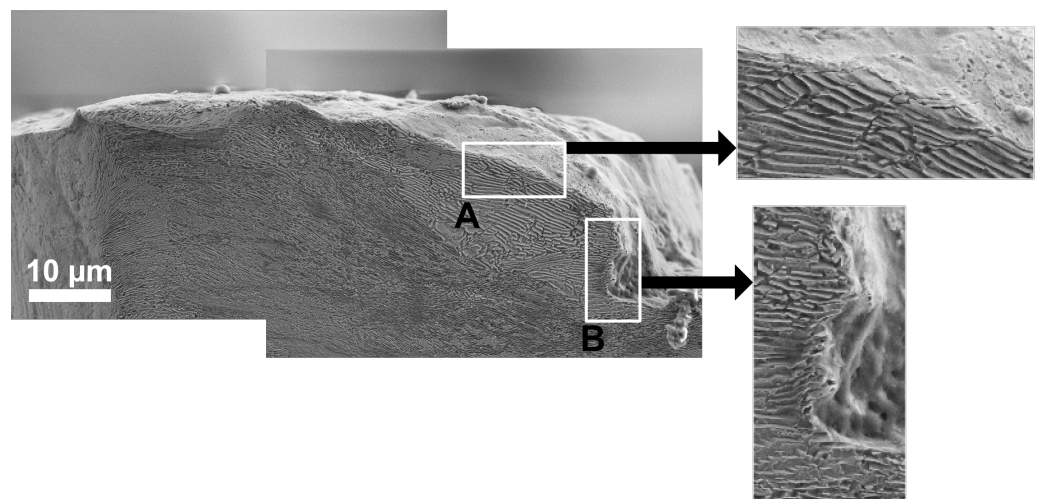
**Figure 17.** Surface crack path (on the lateral surface) for a PD6 test bar. The figure exemplifies the observed variation in crack growth direction on the surface. The detailed views A and B show surface crack growth along and across the cementite lamellae, respectively.
